NEBRASKA BIG PINE CREEK RURAL CLEAN WATER PROGRAM

RURAL CLEAN WATER PROGRAM

10 YEAR REPORT

December, 1991

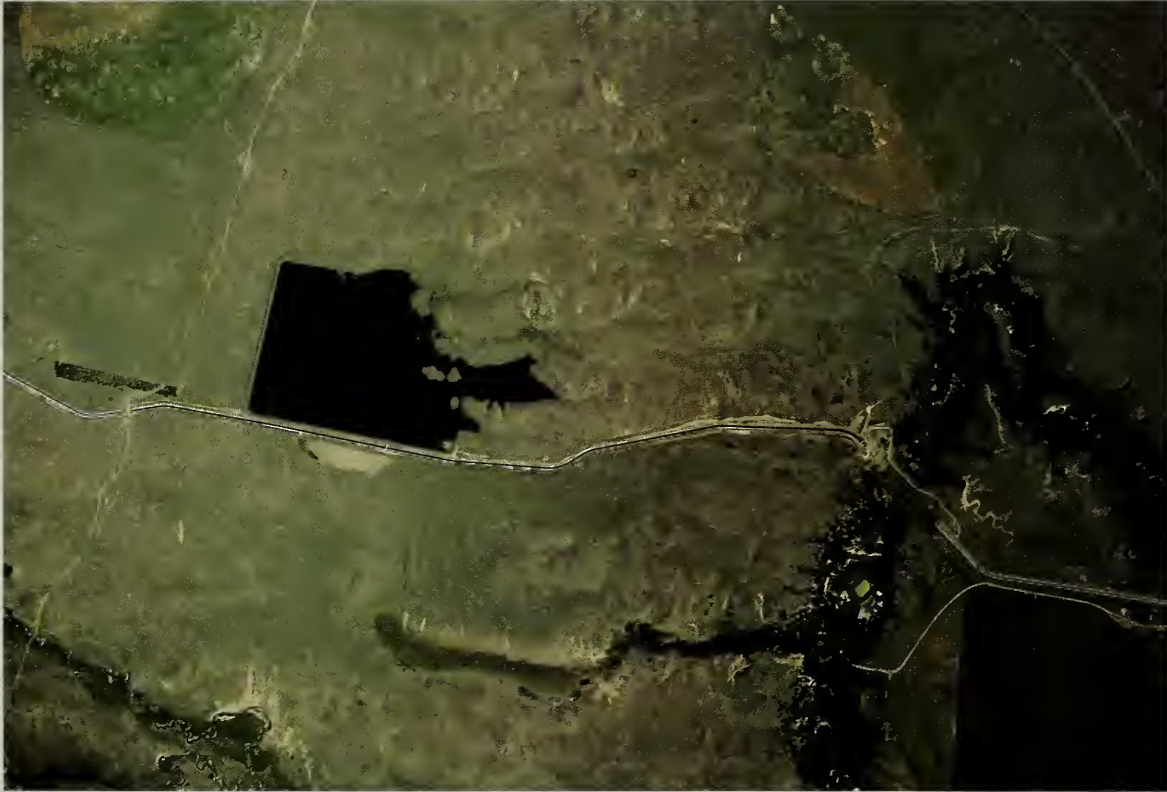
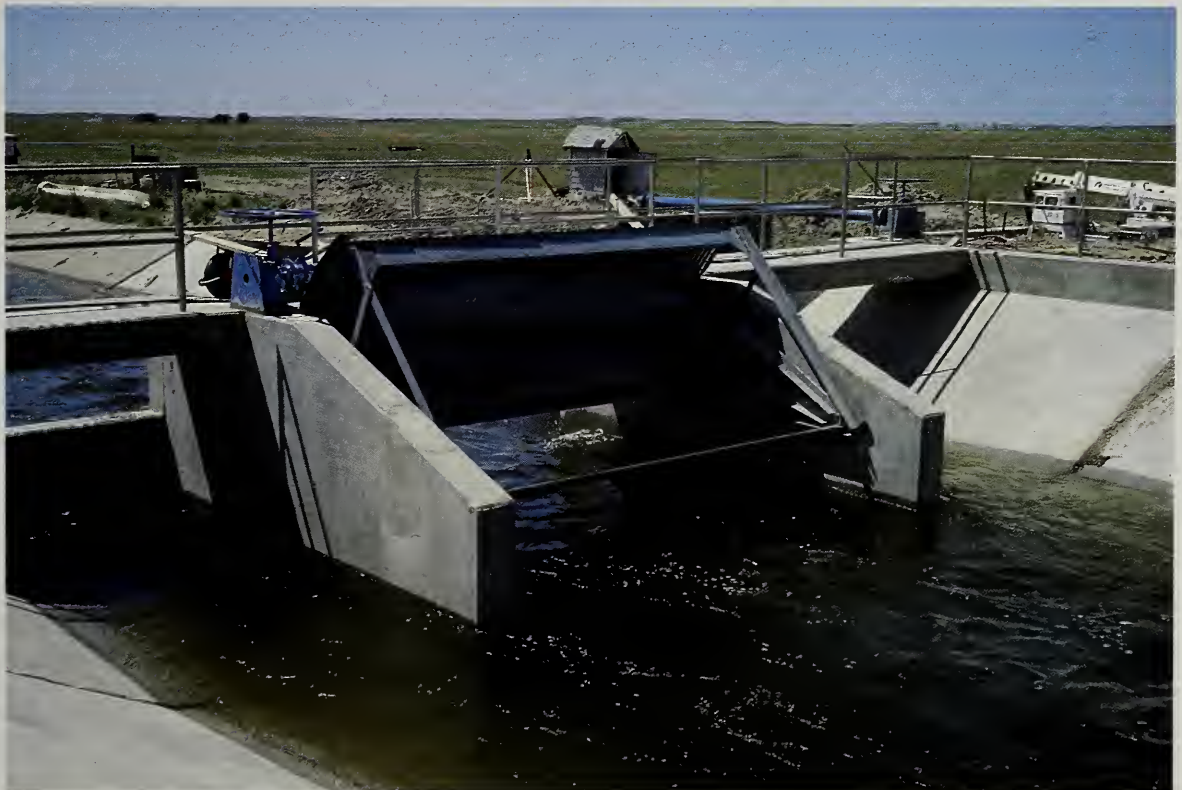
BMP 13 — Improving an Irrigation and/or Water Management System (Ainsworth Irrigation District Secondary Reservoir)

AID Structure In Use — Irrigation Water Diverted Following a Heavy Rain

Diversion Gate — AID Secondary Storage Structure

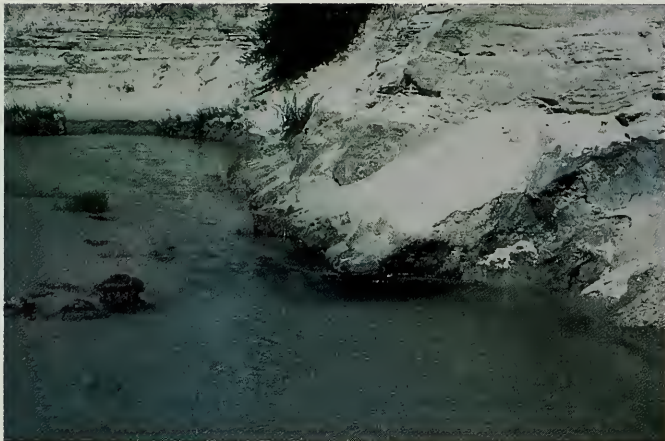
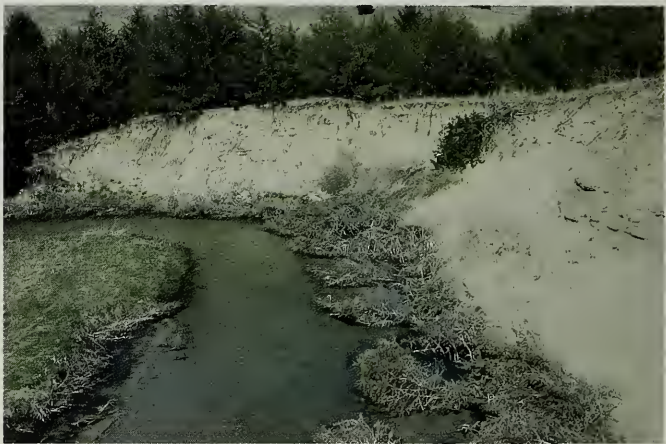
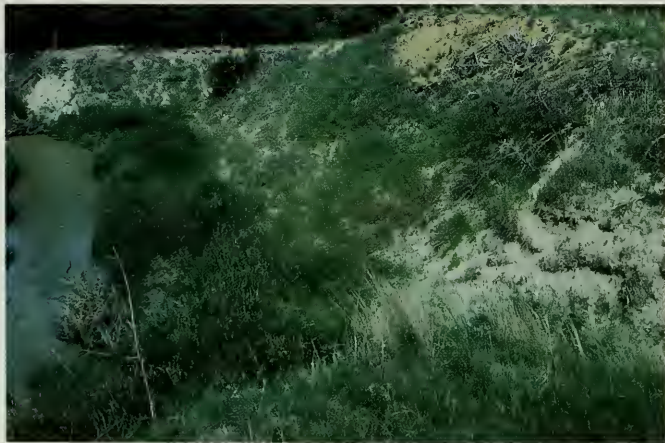
BMP 10 — Streambank Stabilization — Cedar Revetment

Bare Banks, 1984

Revetments Installed, 1986

Reed Canarygrass Established, 1990

Streambank Stabilized, 1991

The first revetments suffered damage from beavers. Immediately after construction of a revetment, beavers would clean the branches off the trees and remove them. It became necessary to cut the trees prior to installation and let them dry out several months or even a year prior to installation.

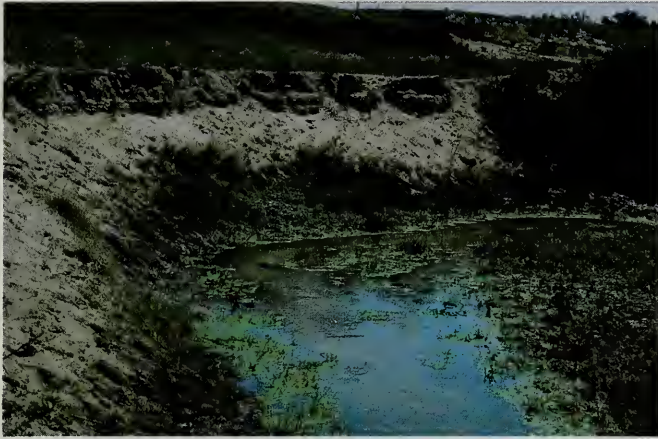
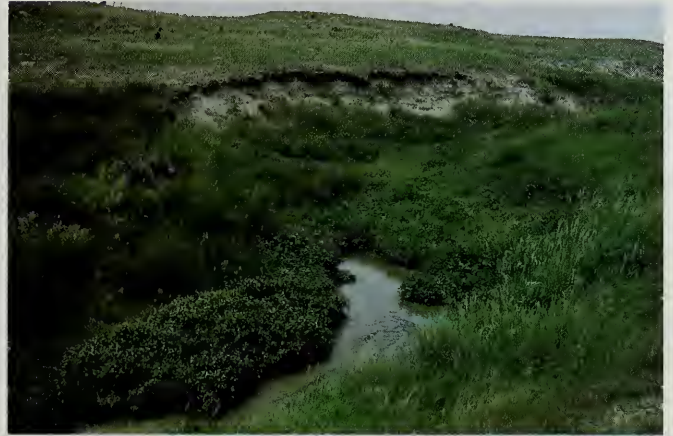
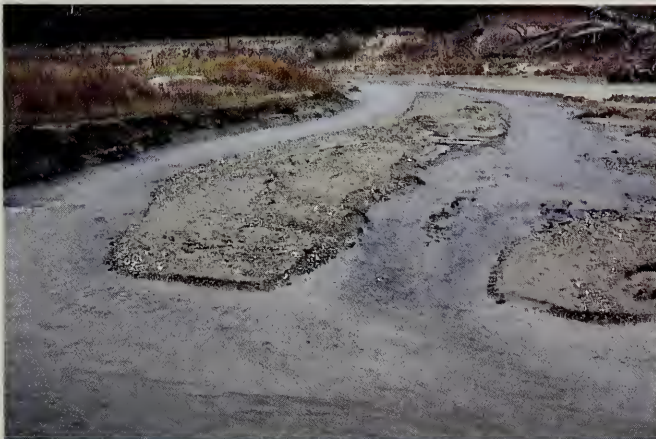
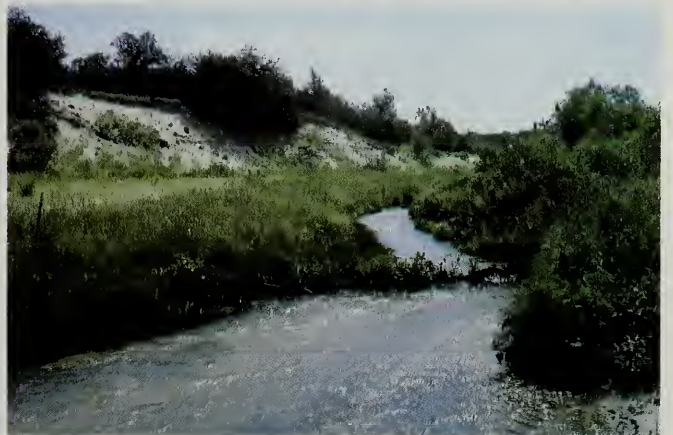
BMP 6 — Grazing Land Protection System (Fencing Livestock From Stream)

Streambank Damage June, 1989

Livestock Excluded From Stream Aug., 1989

Livestock Damage To Channel, 1981

Stream Protected From Livestock, 1990

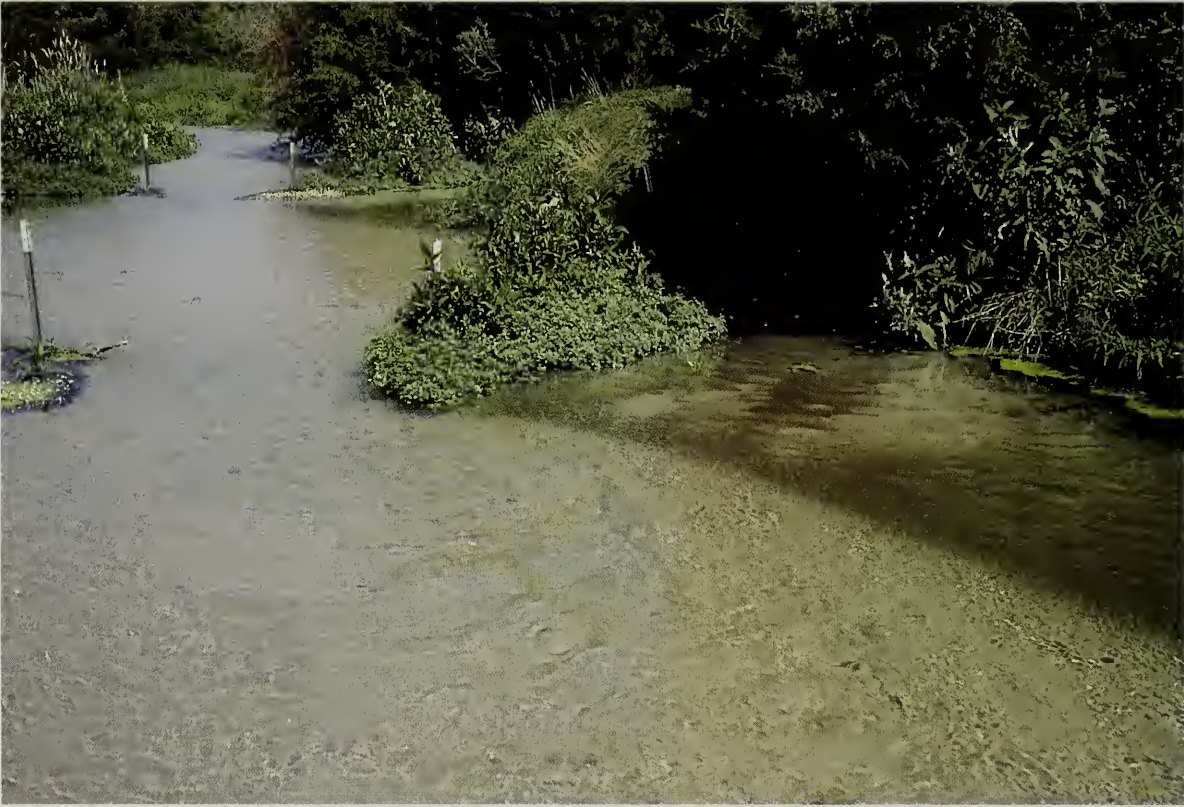
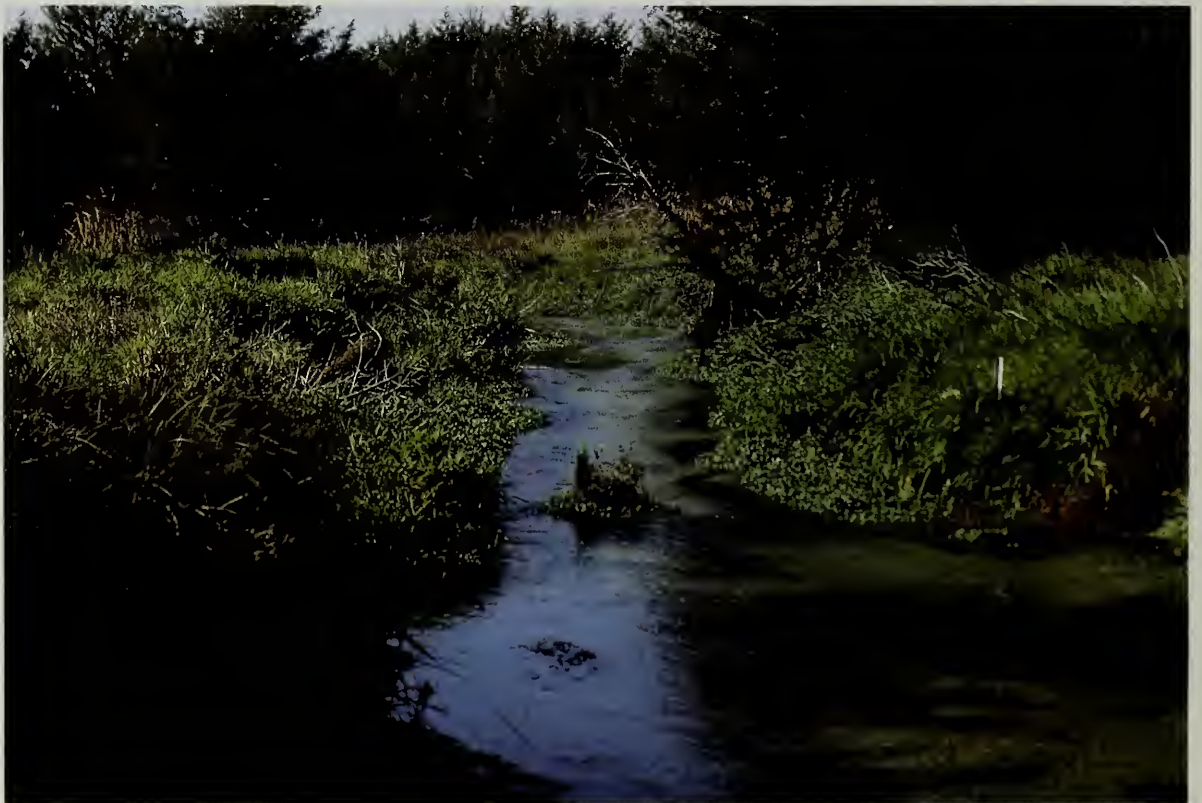
BMP 10 — Stream Protection System

Wing Dikes Six Weeks After Installation, 1985

Wing Dikes Six Years After Installation, 1991

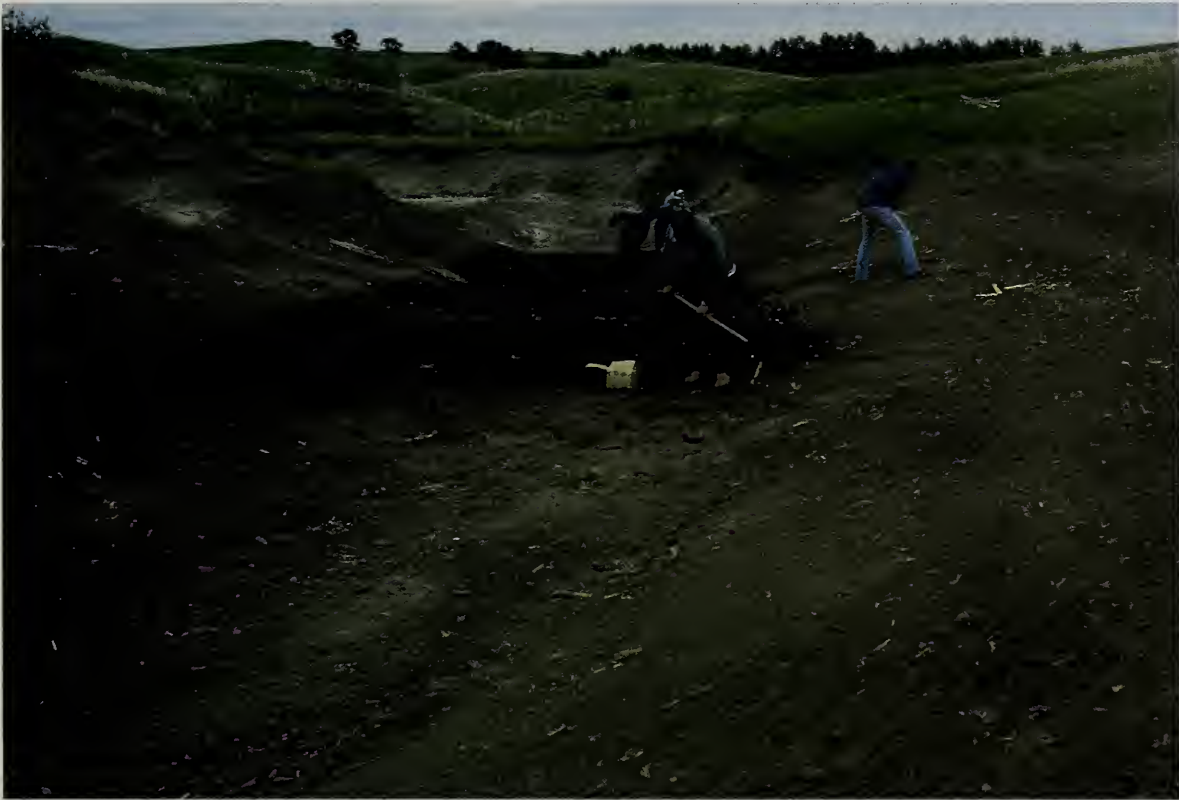
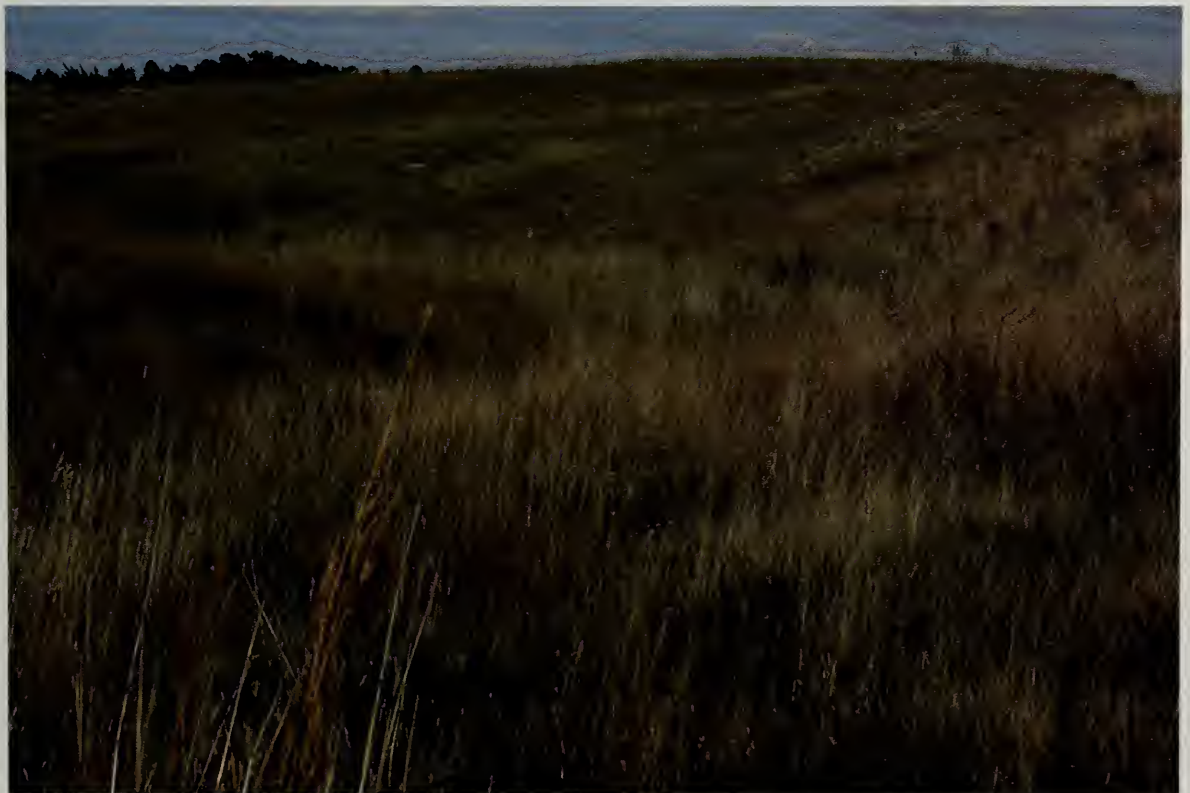
BMP 7 — Waterway System

Experimental Enkamat Installation for Grassed Waterway, 1983

Grassed Waterway Established, 1991

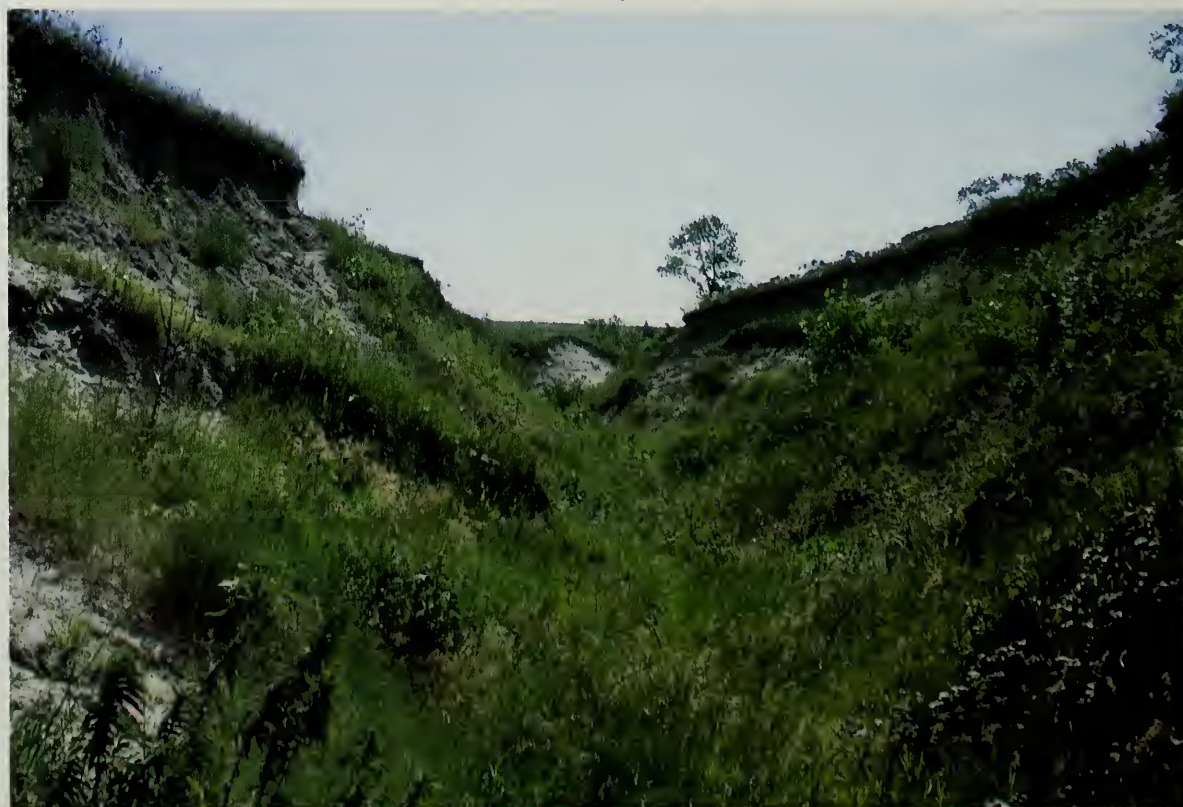
BMP 12 — Sediment Retention, Erosion or Water Control Structure

Severe Gully Erosion, 1984

Gully Revegetated Following Dam Installation, 1990

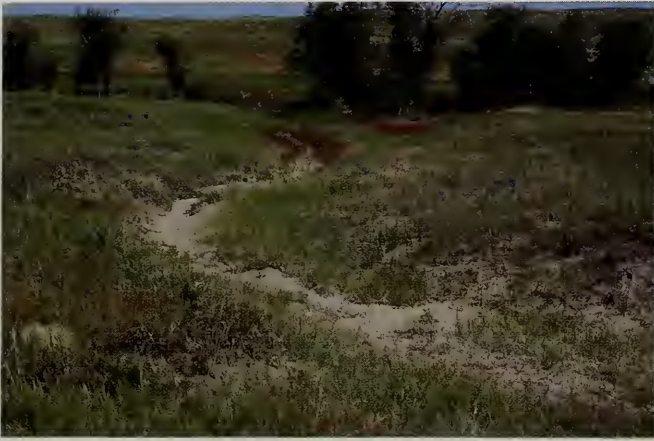
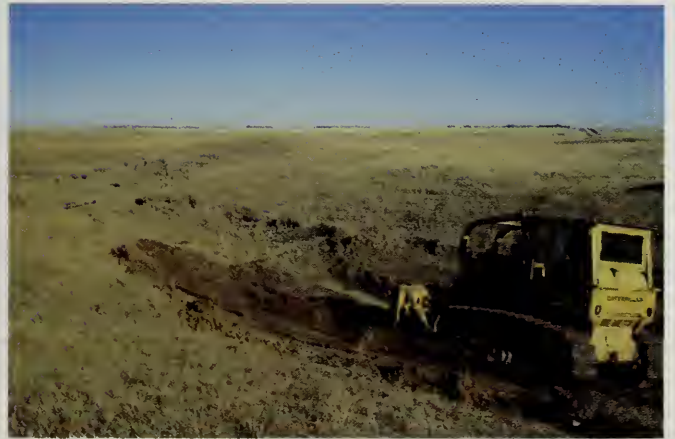
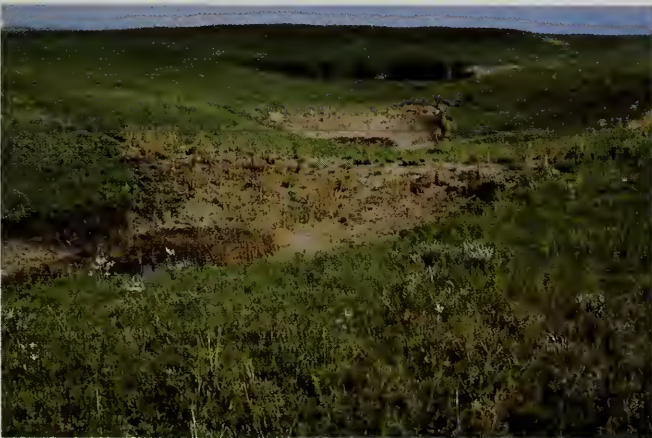
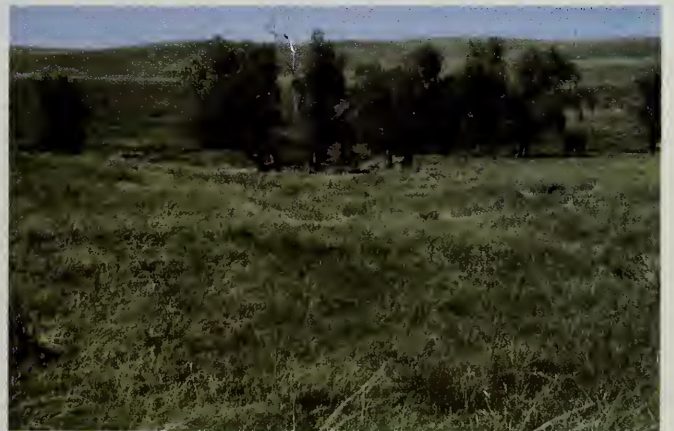
BMP 12 — Sediment Retention, Erosion or Water Control Structure

Eroding Drainage Area, 1985

Dam Construction, 1985

Small Dams Installed, 1985

Drainage Area Revegetated

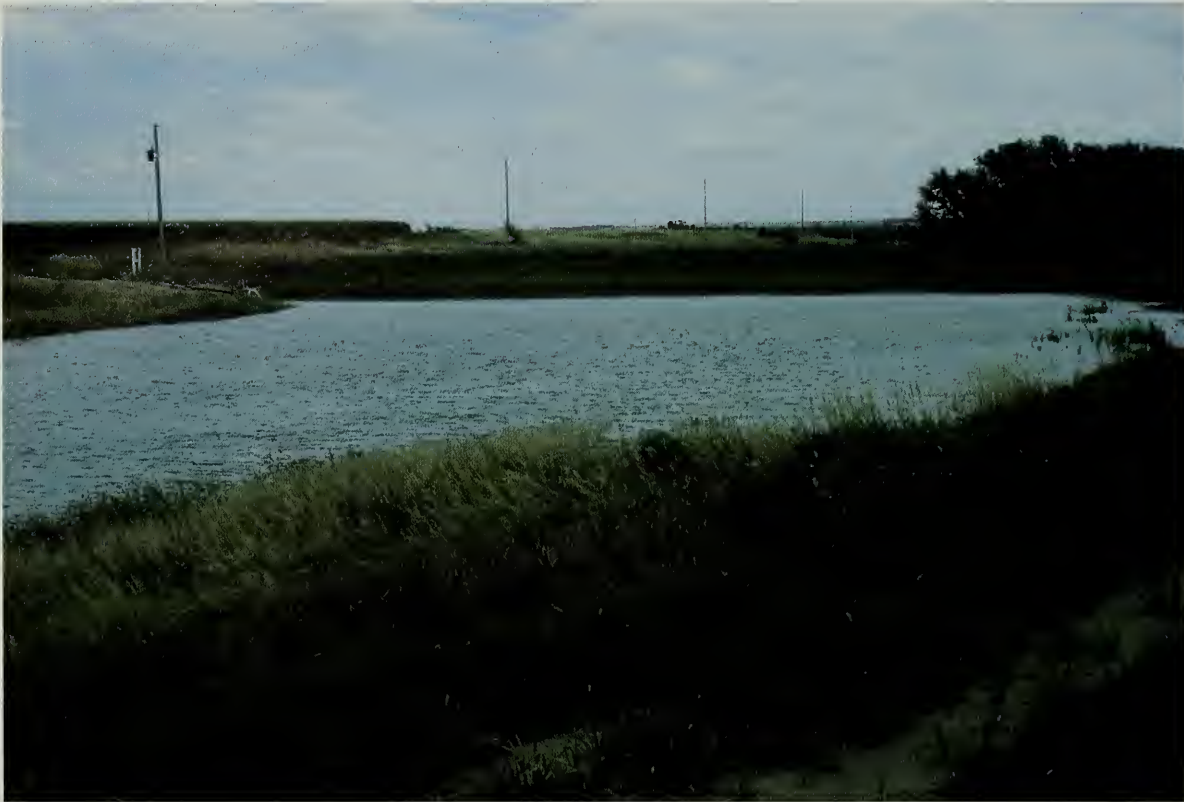
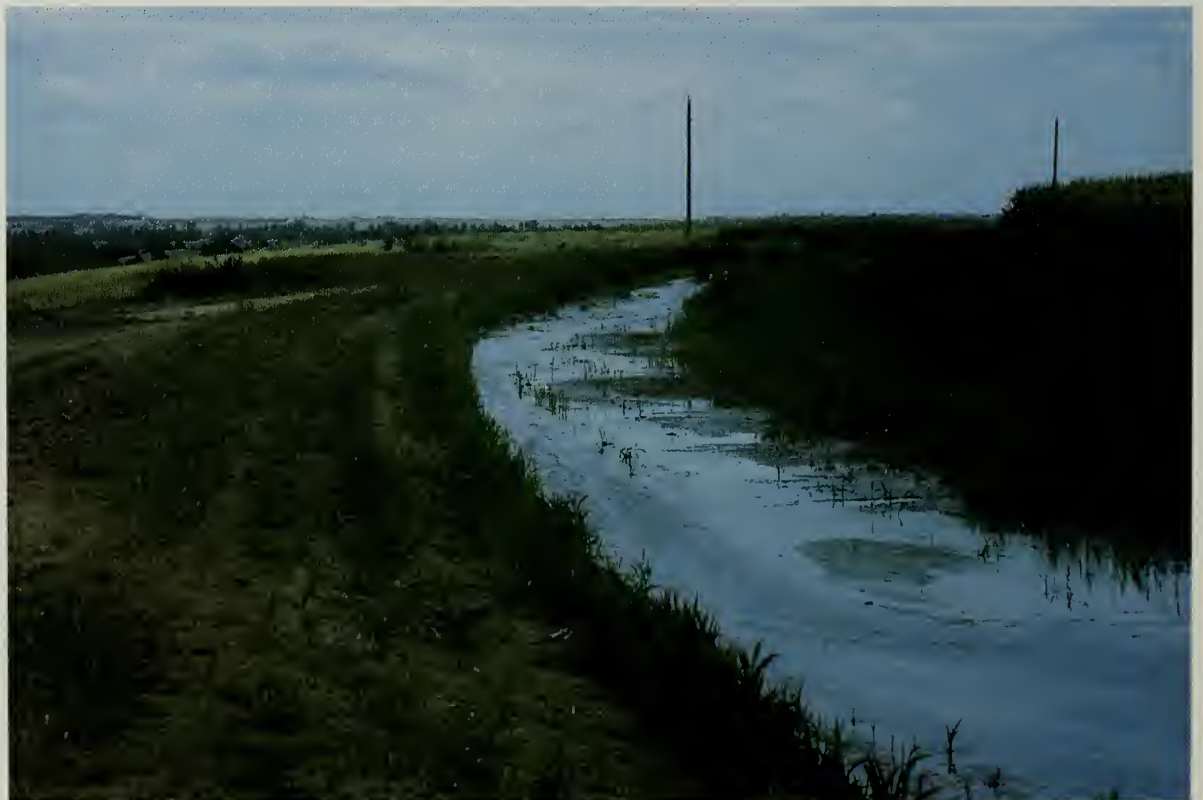
BMP System

BMP 13 — Tailwater Recovery

BMP 5 — Diversion System Diverting Tailwater To Recovery Pit

Practices implemented under BMP 5 greatly improved conditions downstream by diverting water away from critical areas where it could be efficiently utilized.

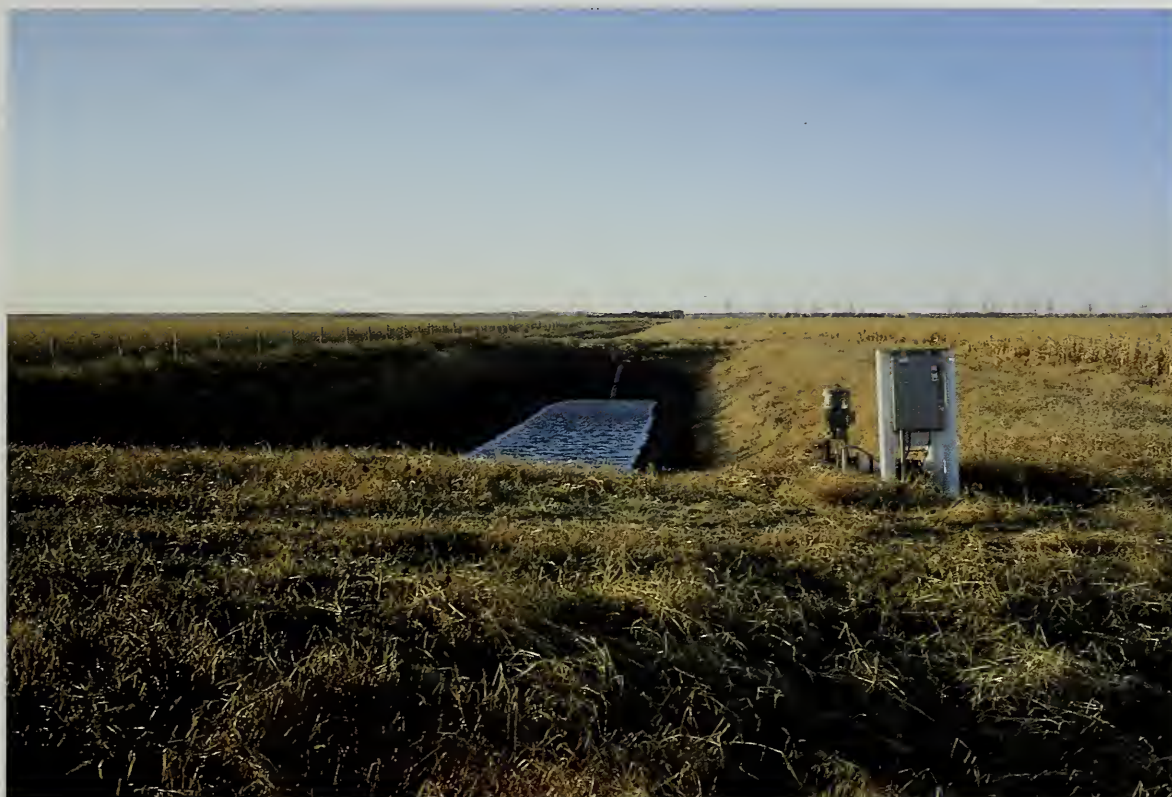
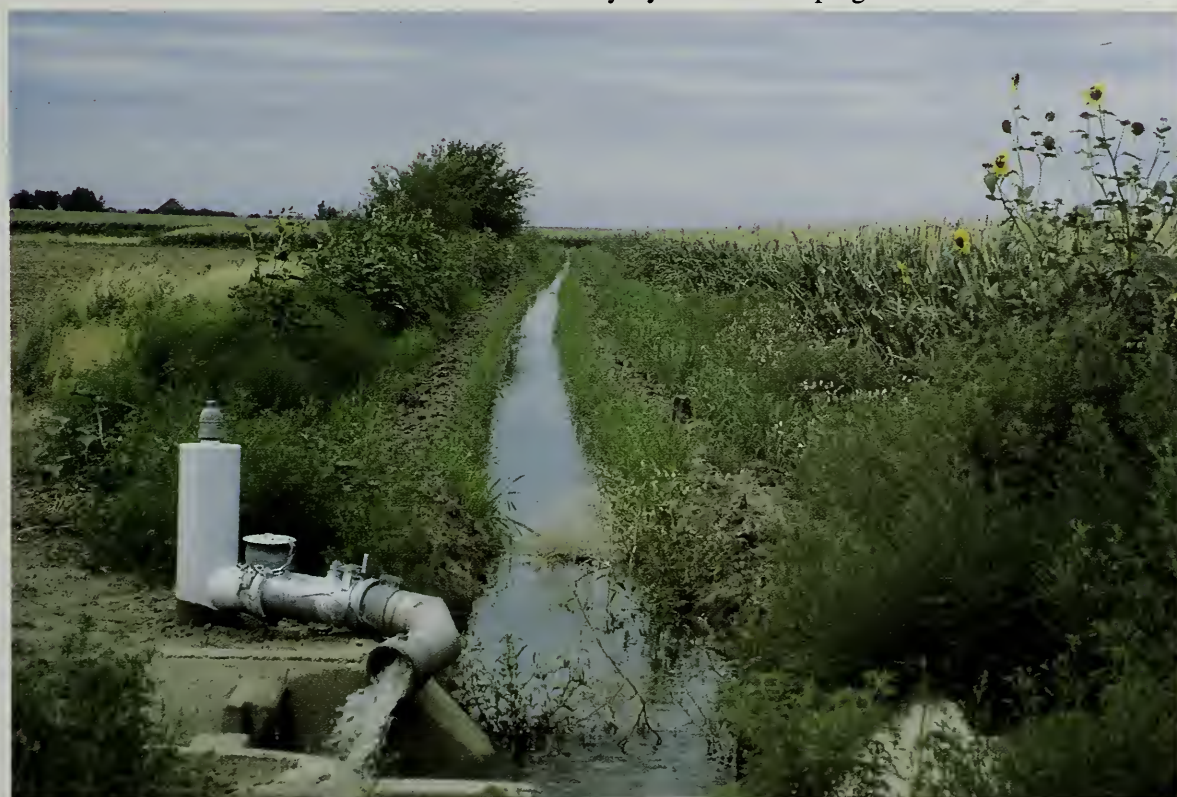
BMP 13 — Improving an Irrigation and/or Water Management System

Tailwater Recovery System — Pit and Pump

Tailwater Recovery System — Pumping Tailwater Back Onto Field

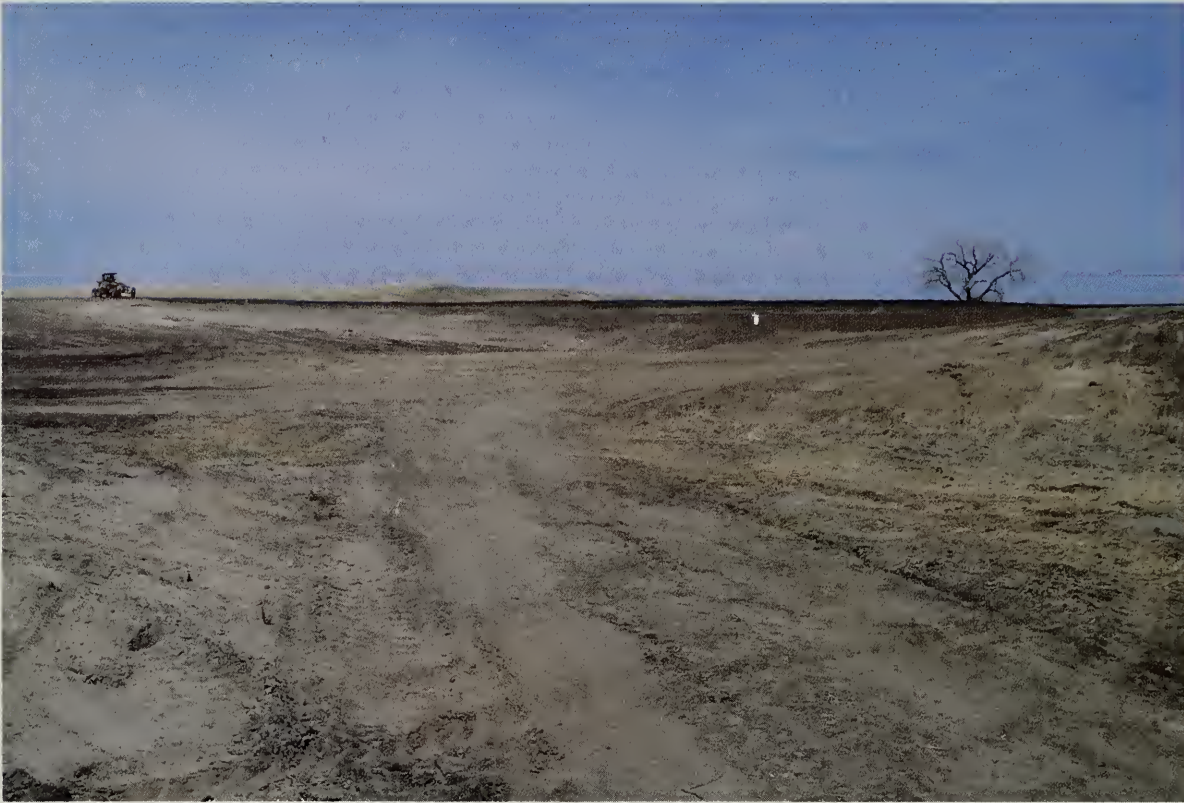
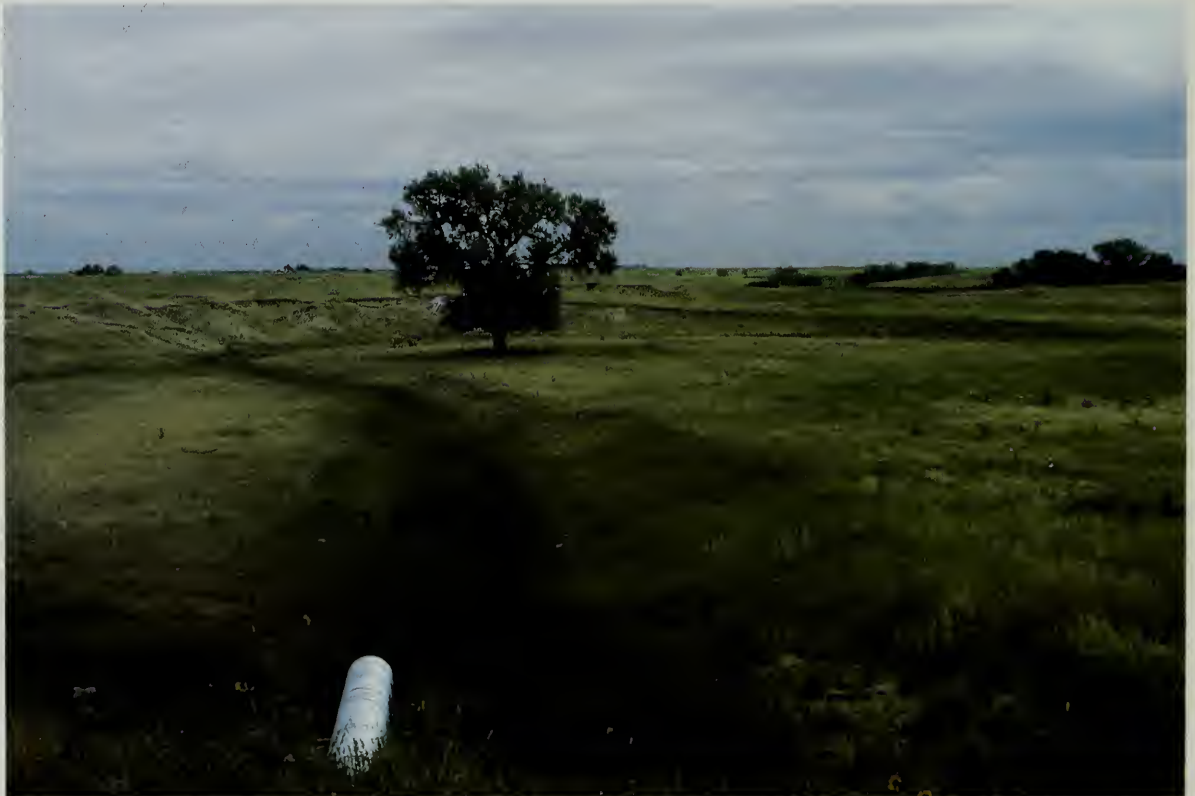
BMP System

Tailwater Recovery and Dam Structure to Stabilize Drainage

Grade Stabilized Below Structure

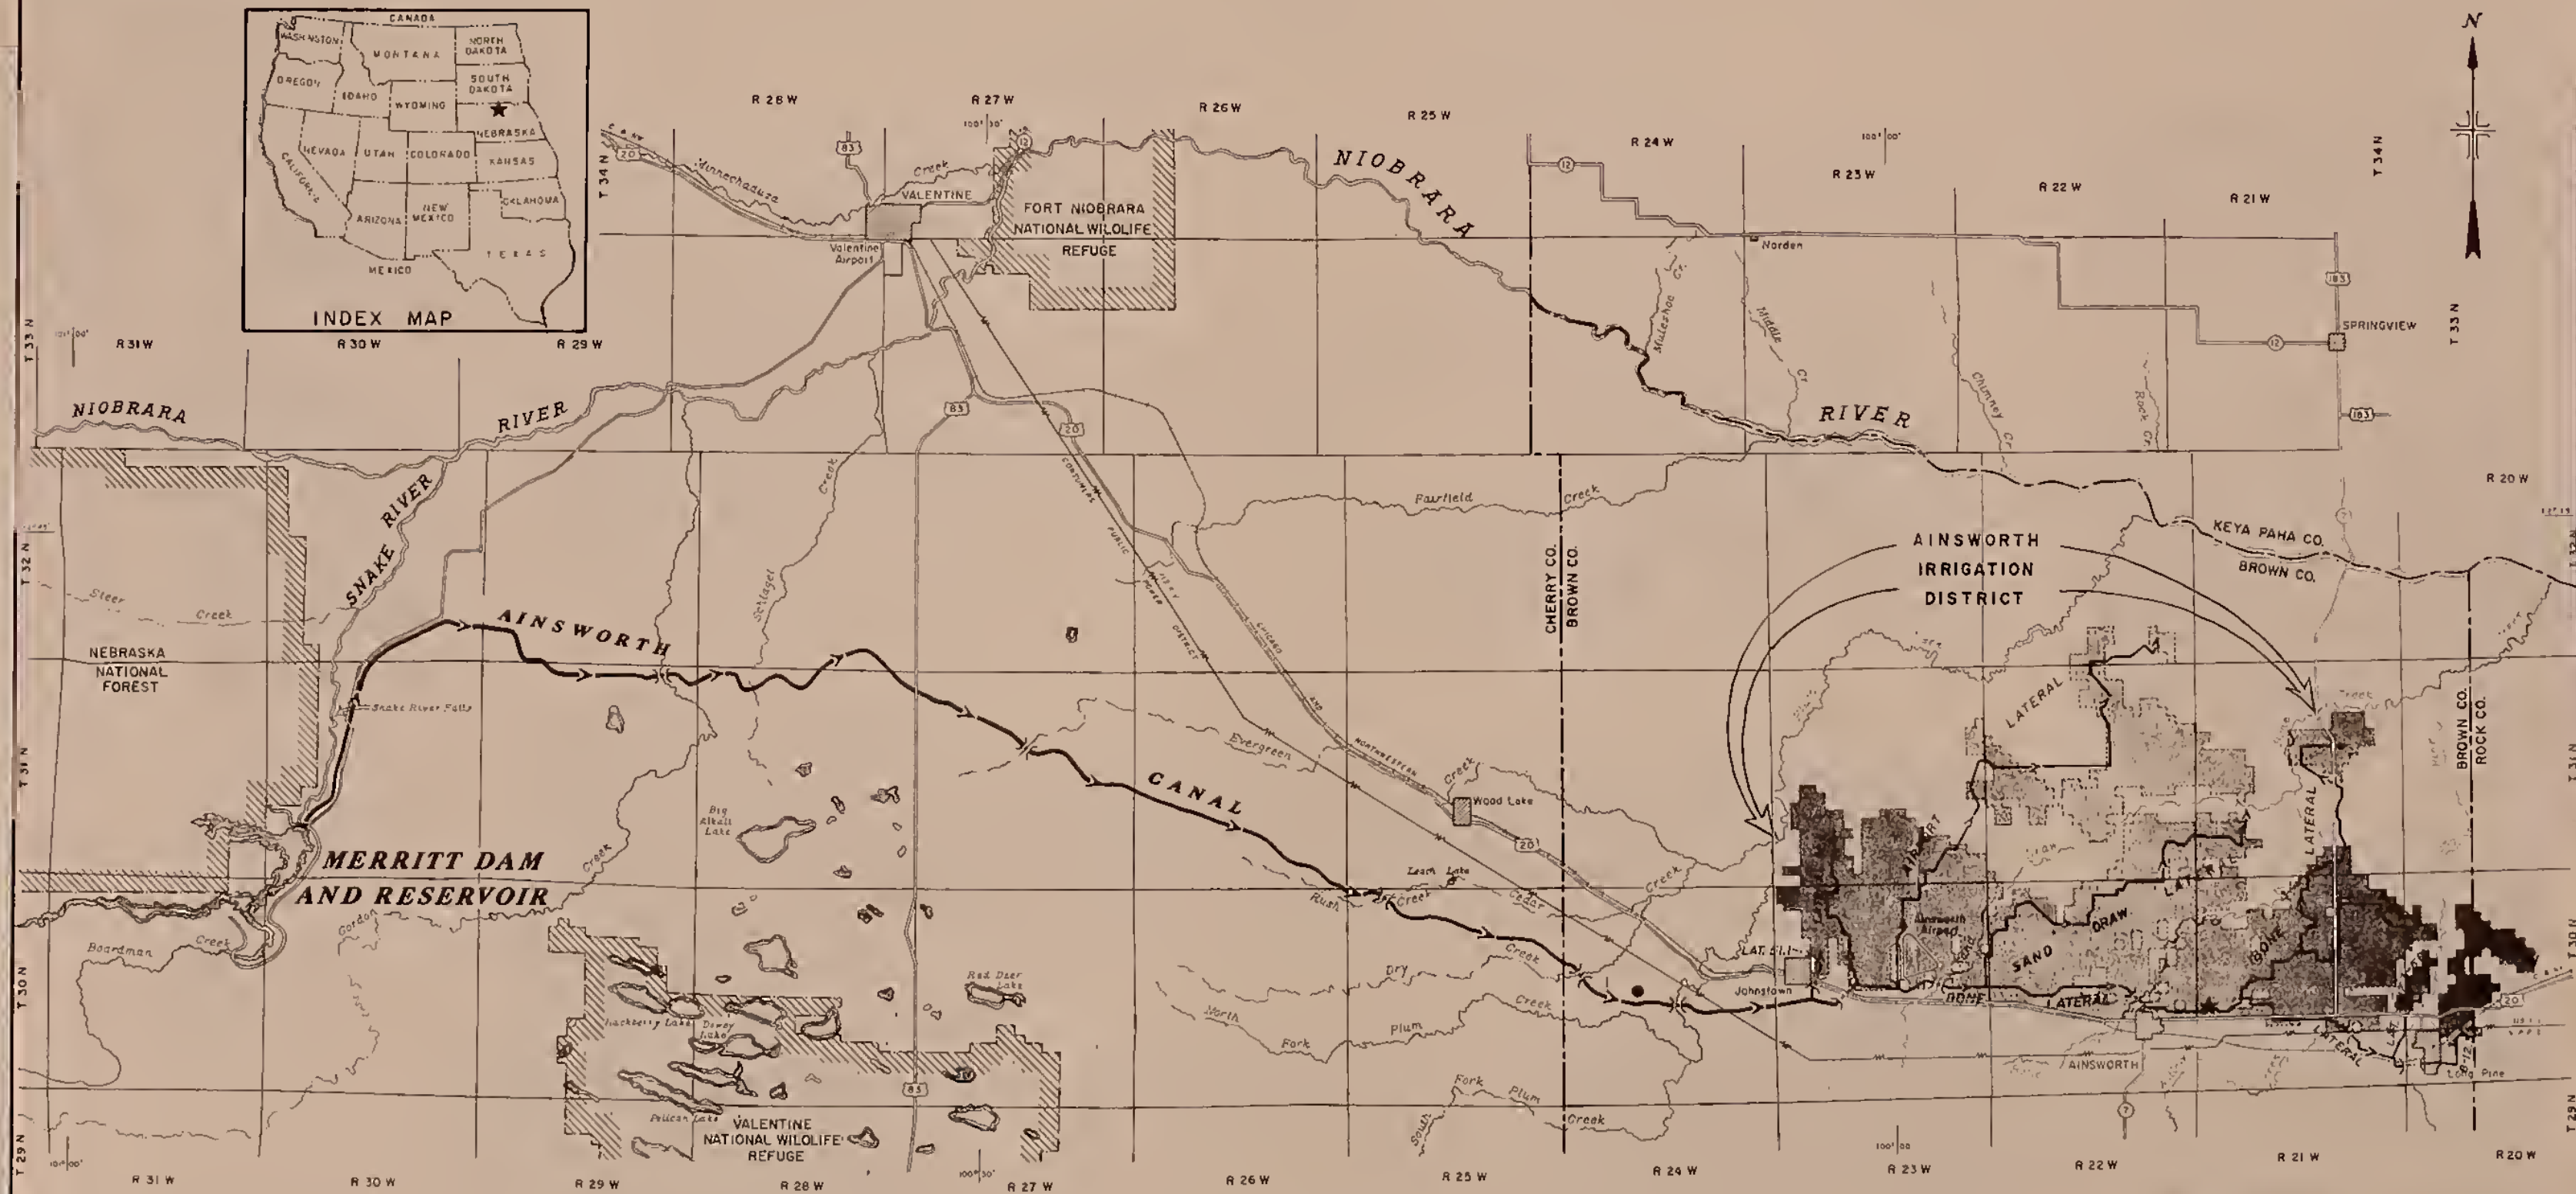
- BUREAU OF RECLAMATION
COMPLETED AND AUTHORIZED WORKS
- DAM AND RESERVOIR
 - CANAL AND LATERAL
 - SIPHON
 - AINSWORTH IRRIGATION DISTRICT HEADQUARTERS
 - AREA BENEFITED BY PROJECT WORKS
 - AIO SECONDARY STORAGE STRUCTURE

The morning-glory type ungated spillway protects the dam from damage by floods. A branched outlet works provides for diverting water to the Ainsworth Canal or for controlling releases to the Snake River through the spillway stilling basin.

The AINSWORTH CANAL originates at Merritt Dam outlet works and extends eastward through the sandhills to the project lands. It is concrete lined for its entire length to minimize seepage losses in the sandy soils it traverses. An extensive lateral system delivers water to the irrigable lands.
